# 1983 Chapel Restoration

This report documents the conservation work carried out at the Pandosy Mission Historic site on the Father Pandosy Chapel between September 29 and December 20 of 1983. The project was initiated and funded by the Building Committee of the Okanagan Historical Society, with the support of a grant from the B.C. Heritage Trust.

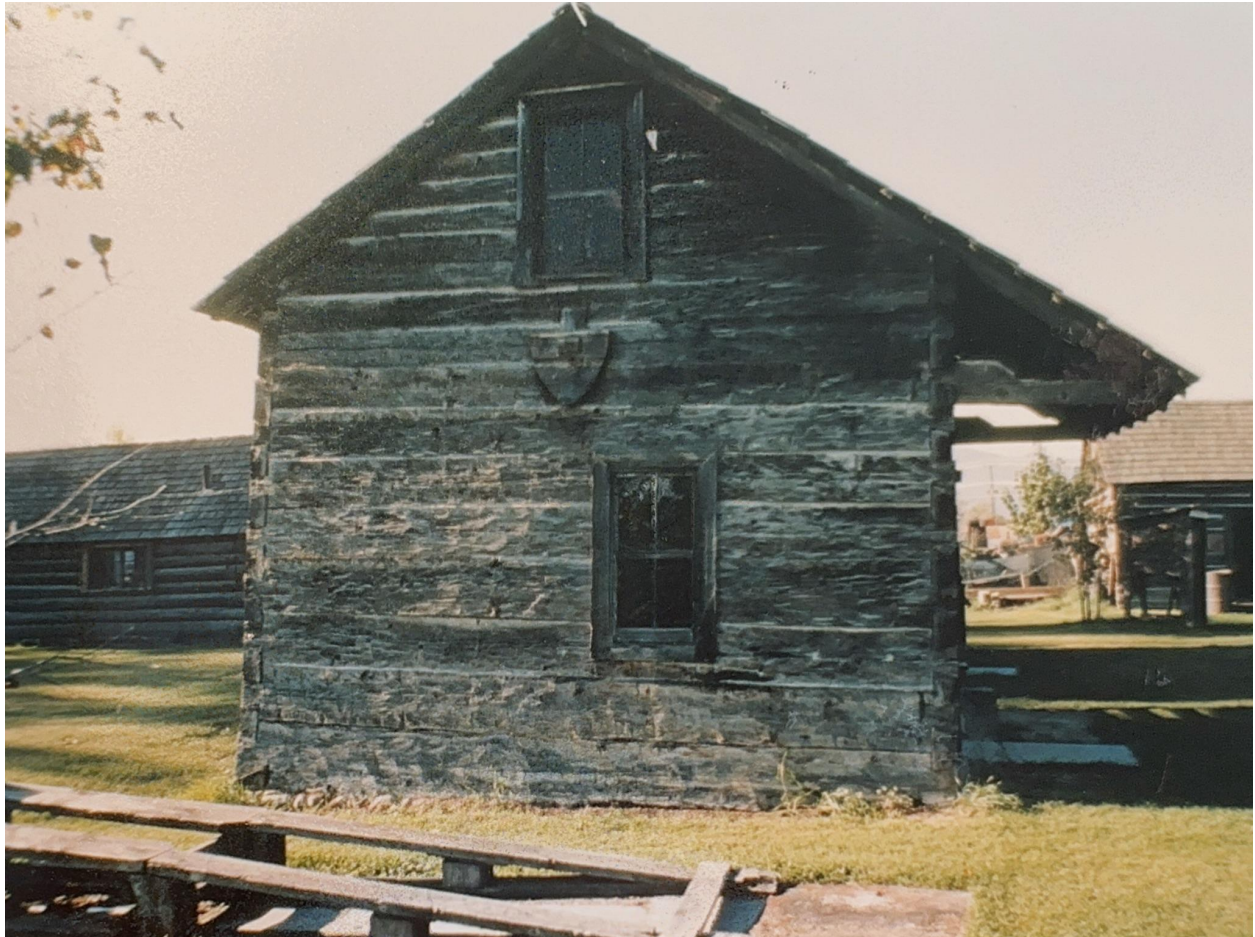
P-7

Father Pandosy's Chapel build in 1860 has undergone a number of renovations over the years, as a result the original structure is still quite intact.

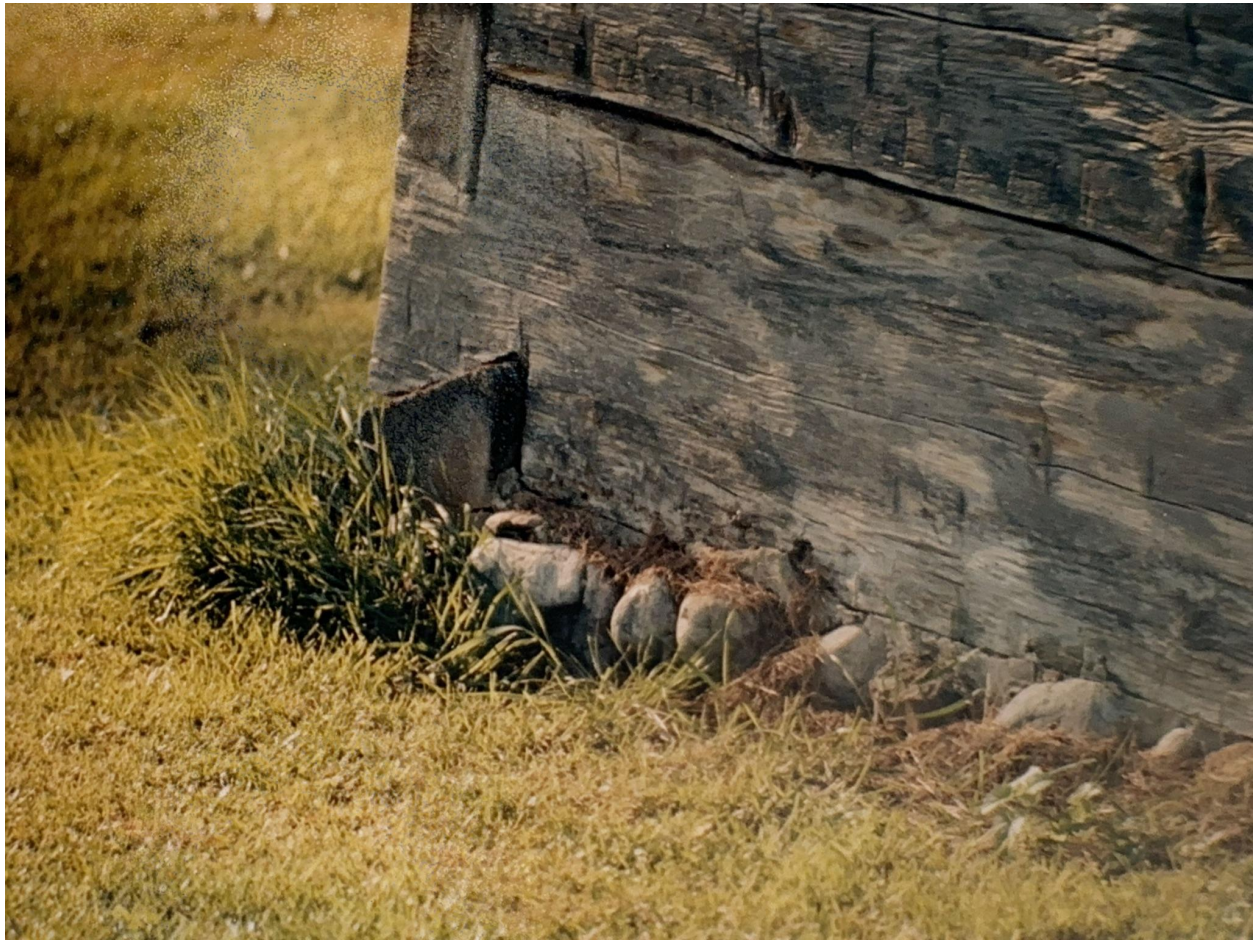
P-6

Although some work has been done on the foundation, the sill logs still rest on the ground, absorbing moisture and rotting.

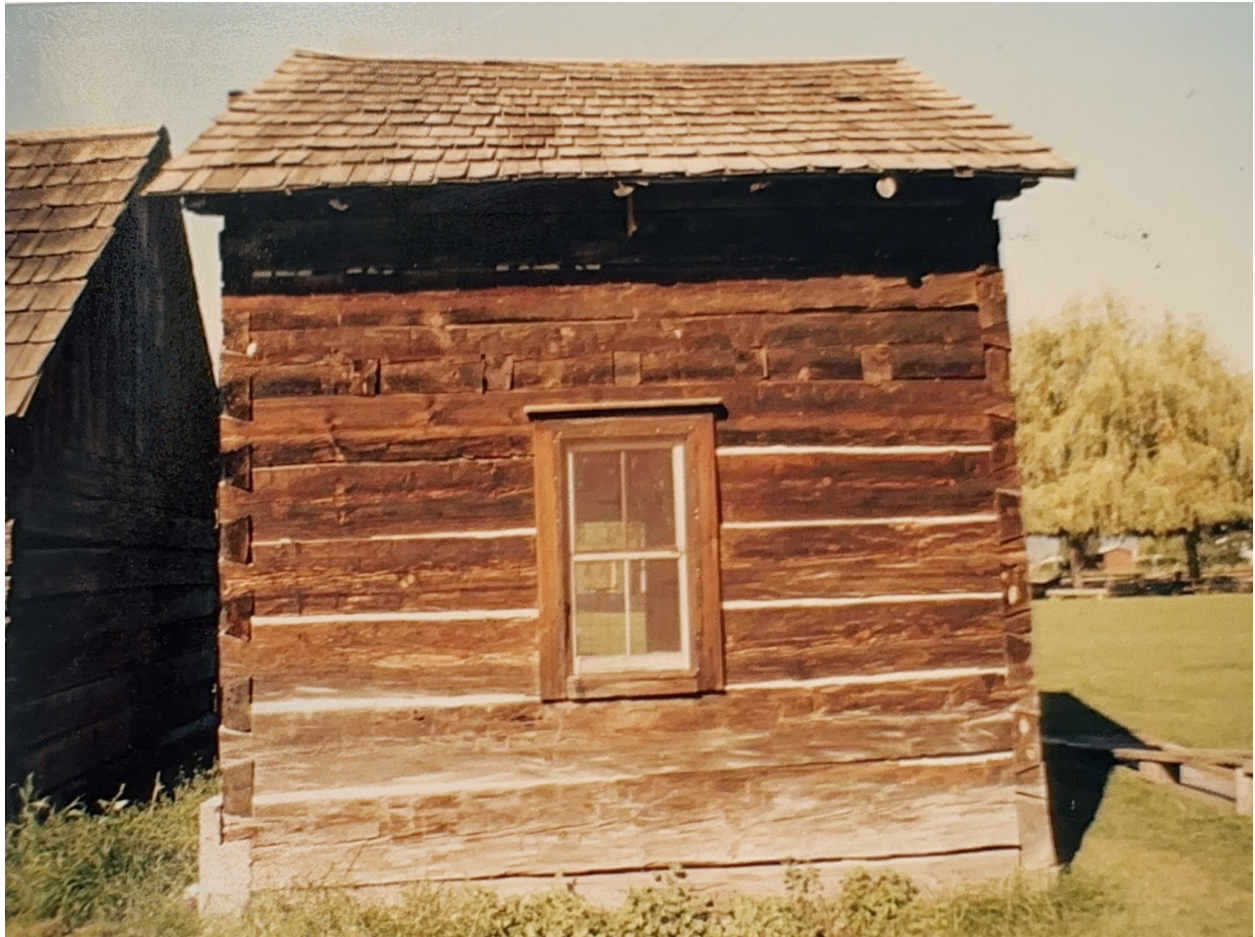
P-5

A number of neatly crafted features such as the notched ceiling joists are the trademarks of early craftsmen. The building was found to be considerably out of level even though a few new footing had been poured on two sides.

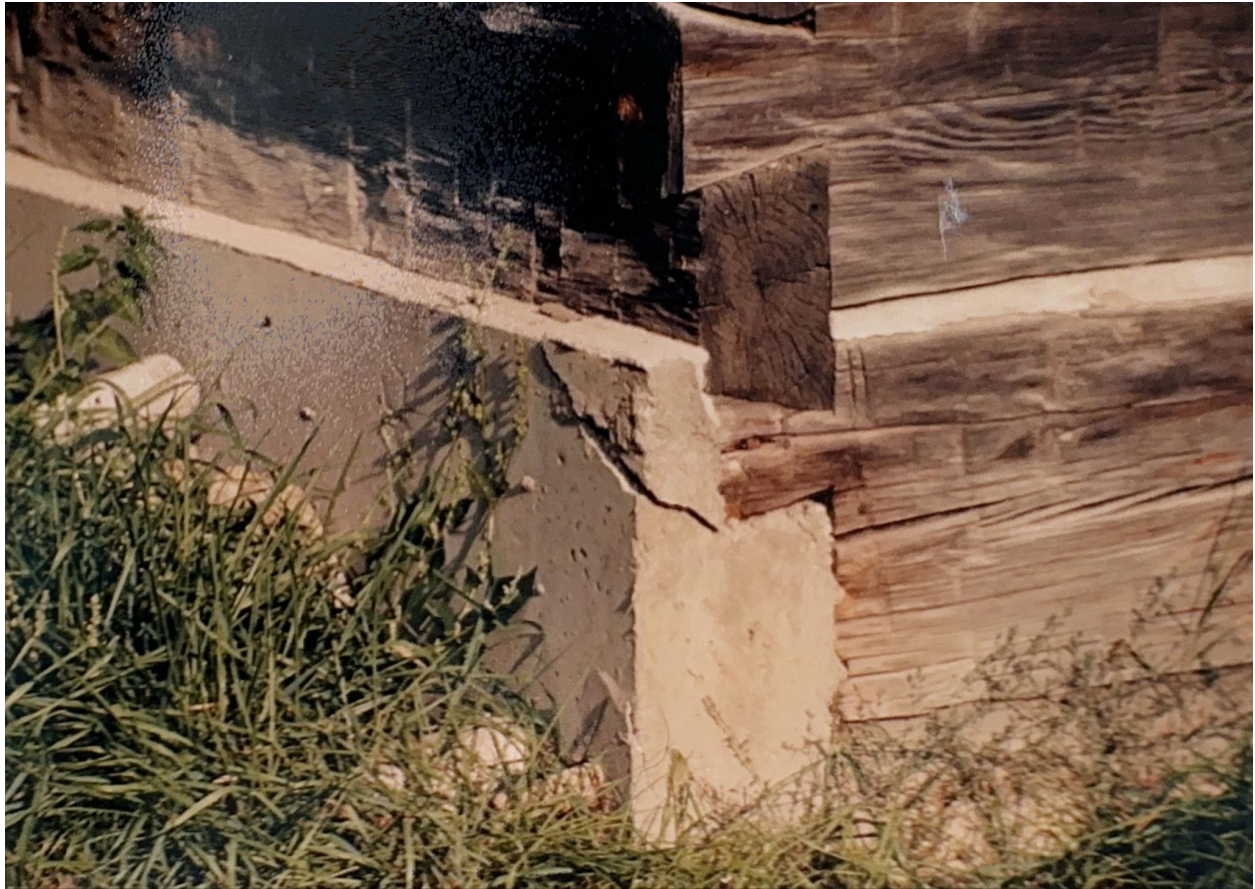
P-4

In the interest of saving the building volunteers found pouring a log in place the simplest solution to the dry rot problem. In this case the wall logs are imbedded in concrete heightening the risk of moisture related problems.

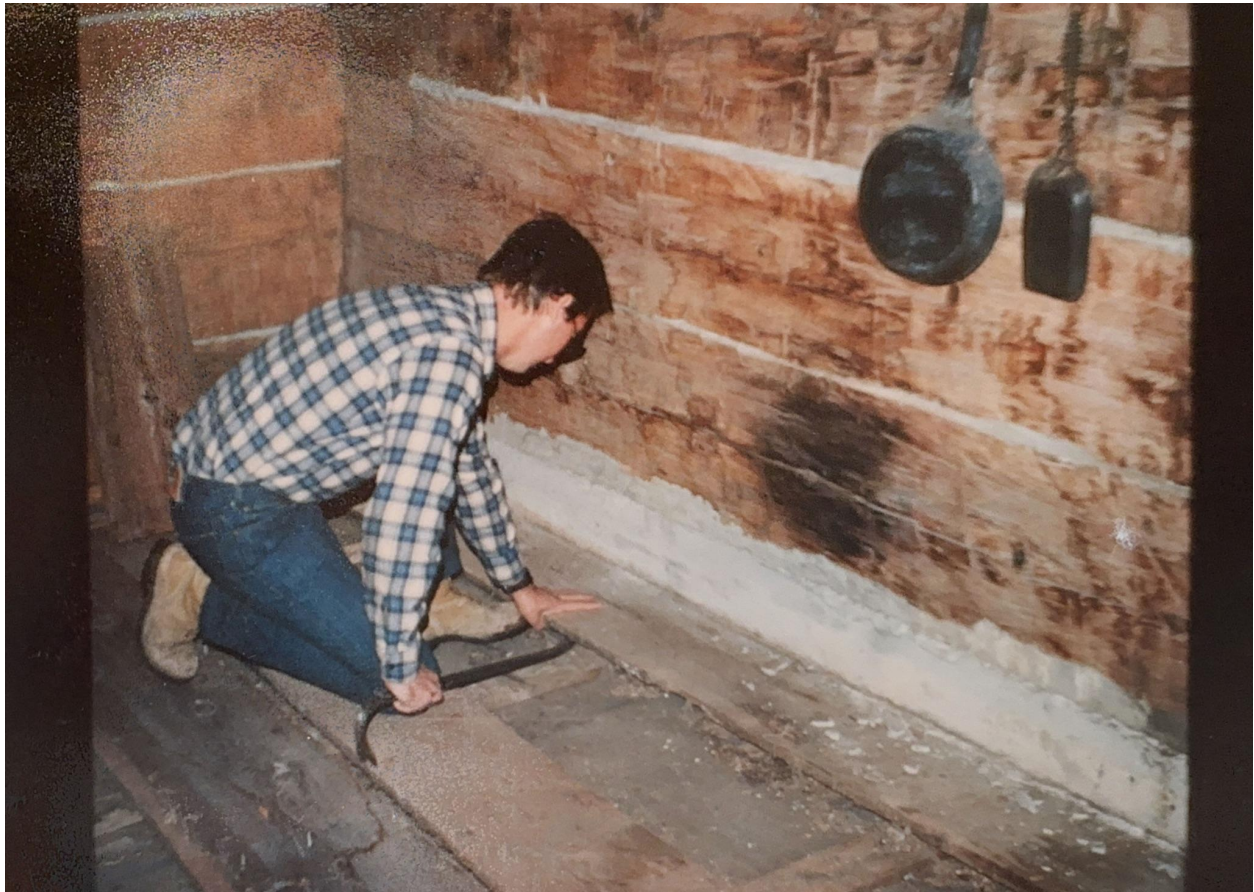
P-2

Concrete used in the stabilization program covered the lower section of the logs, the discolouration had to be removed with a wire brush and cleaning agents.

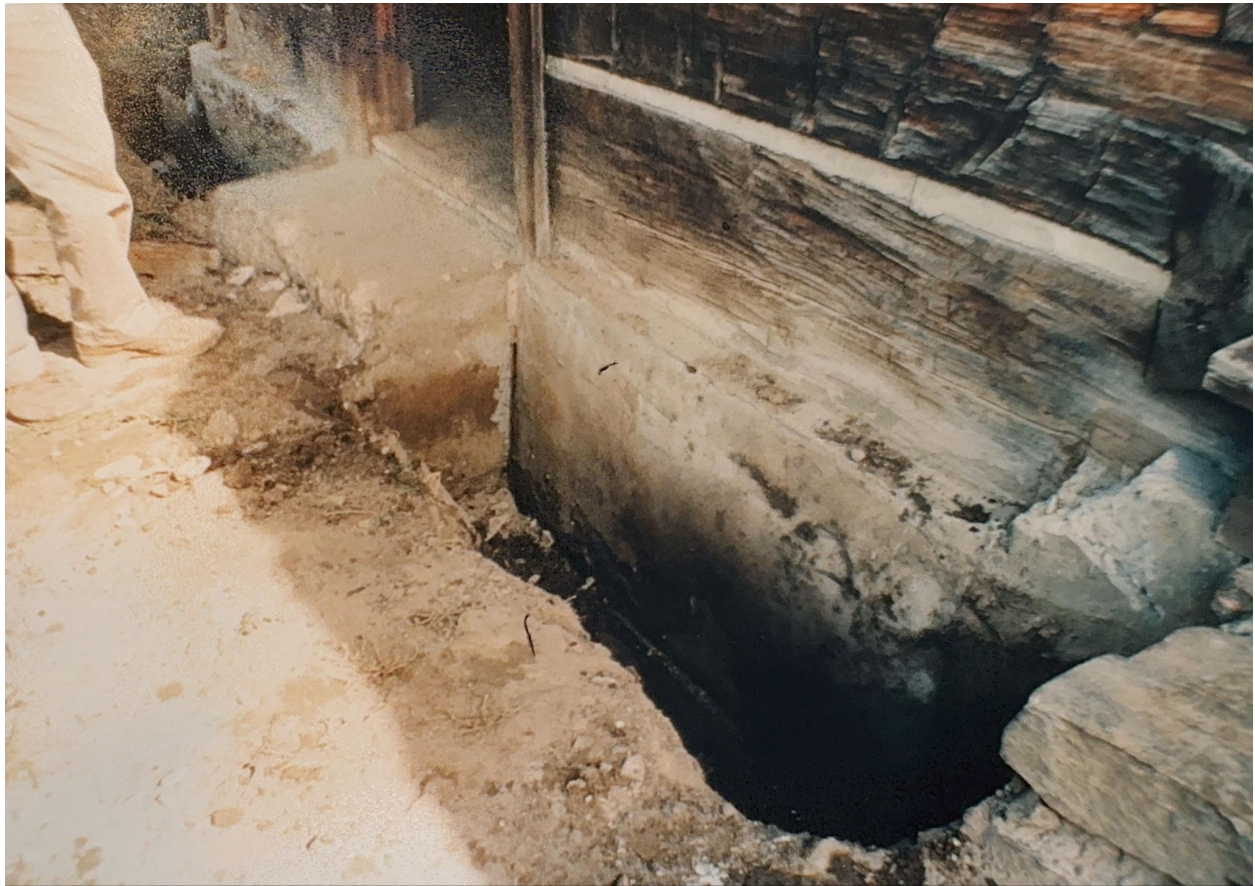
P-13

Excavation of the concrete footing revealed the depth of the cement was up to three feet, in some cases the wall ford was over a foot thick.

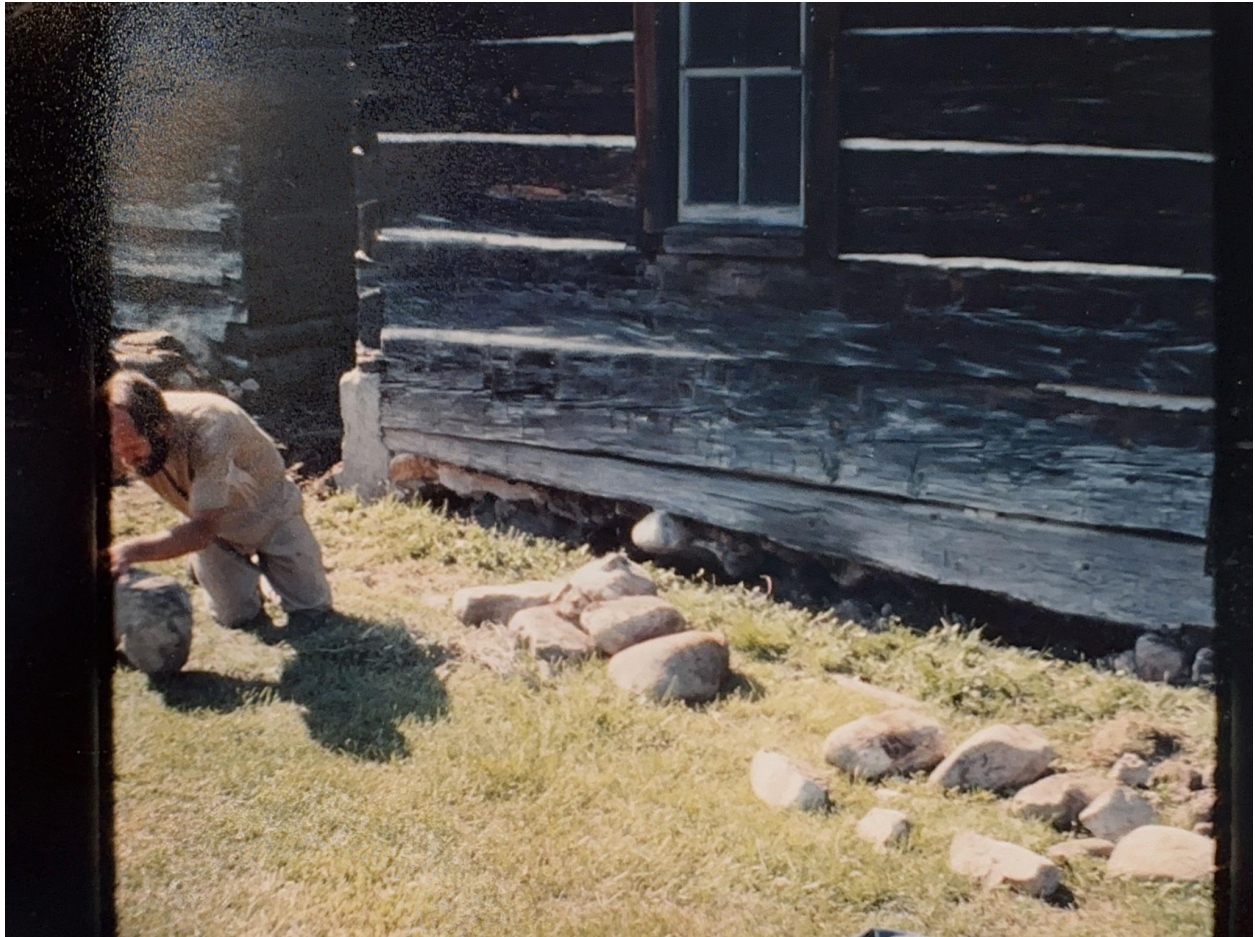
P-10

Foundation rocks have been used to fill-in open sections at the base of the building created by decaying logs. The thin taper of the sill log on the east wall is an example of the structural conditions requiring attention.

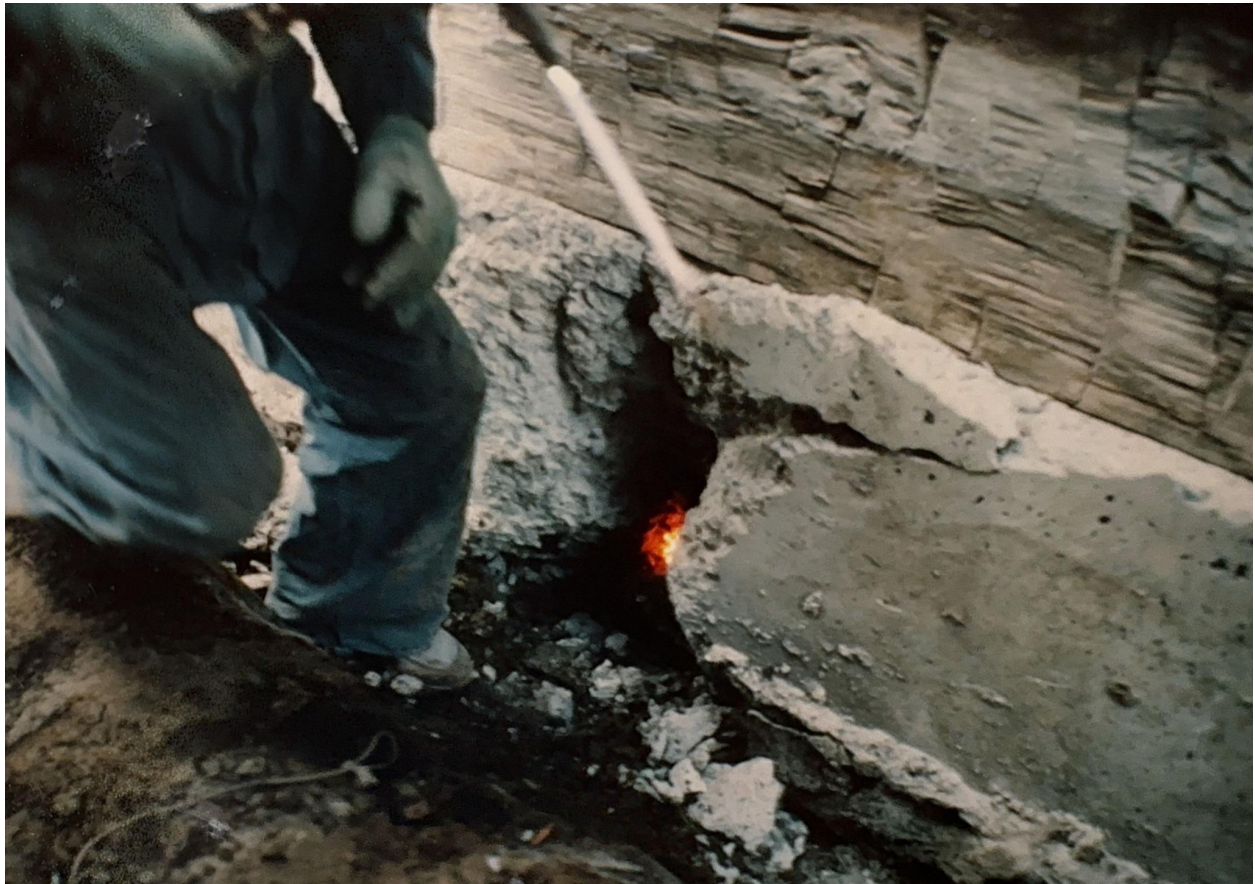
P-18

The removal of the concrete was complicated by reinforcing steel, a torch was used to cut the sections apart. The builders of this foundation no doubt wanted a clear conscience.

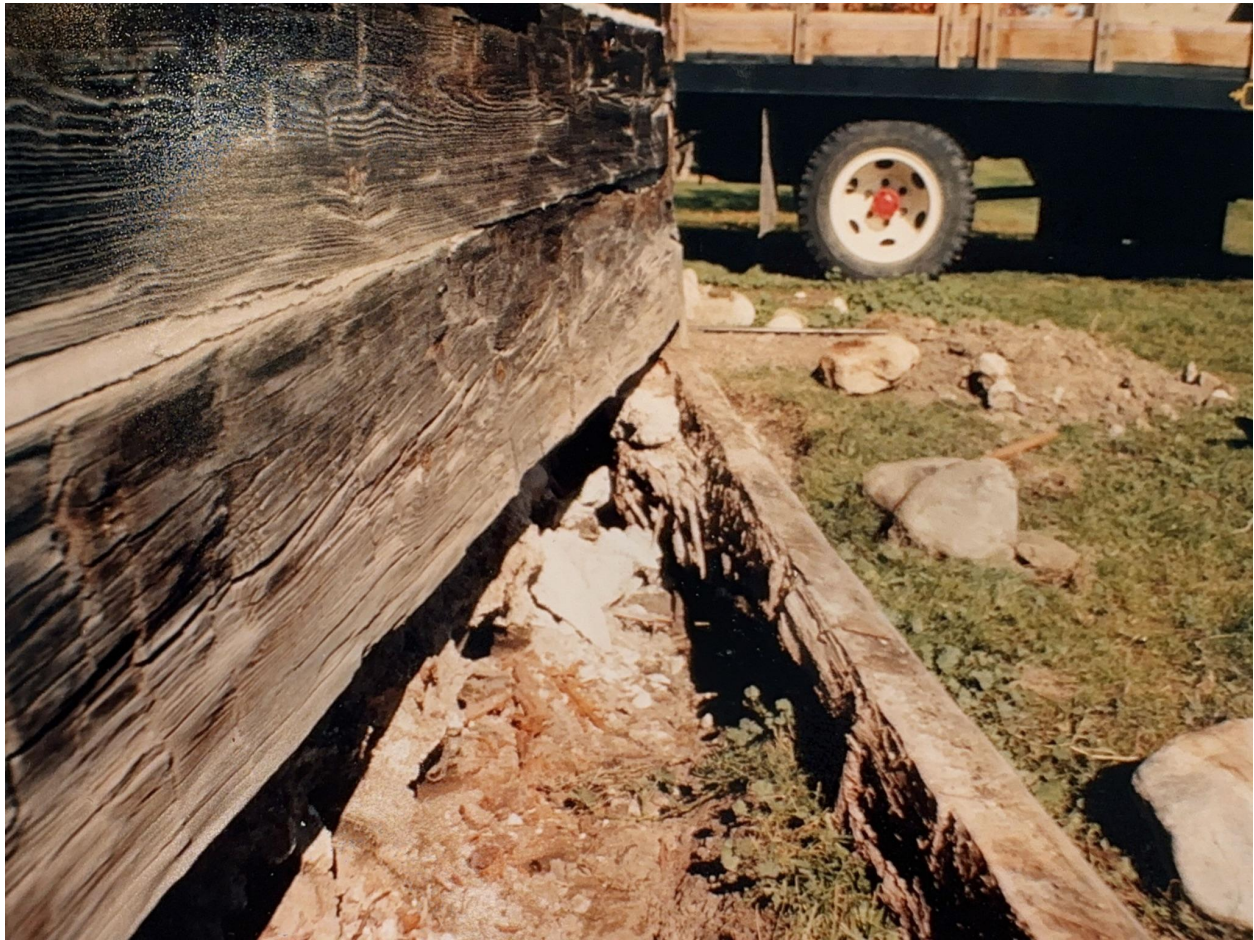
P-23

The rotted section of sill log removed from the east wall of the Chapel revealed critical information for the reconstruction of the floor joist structure.

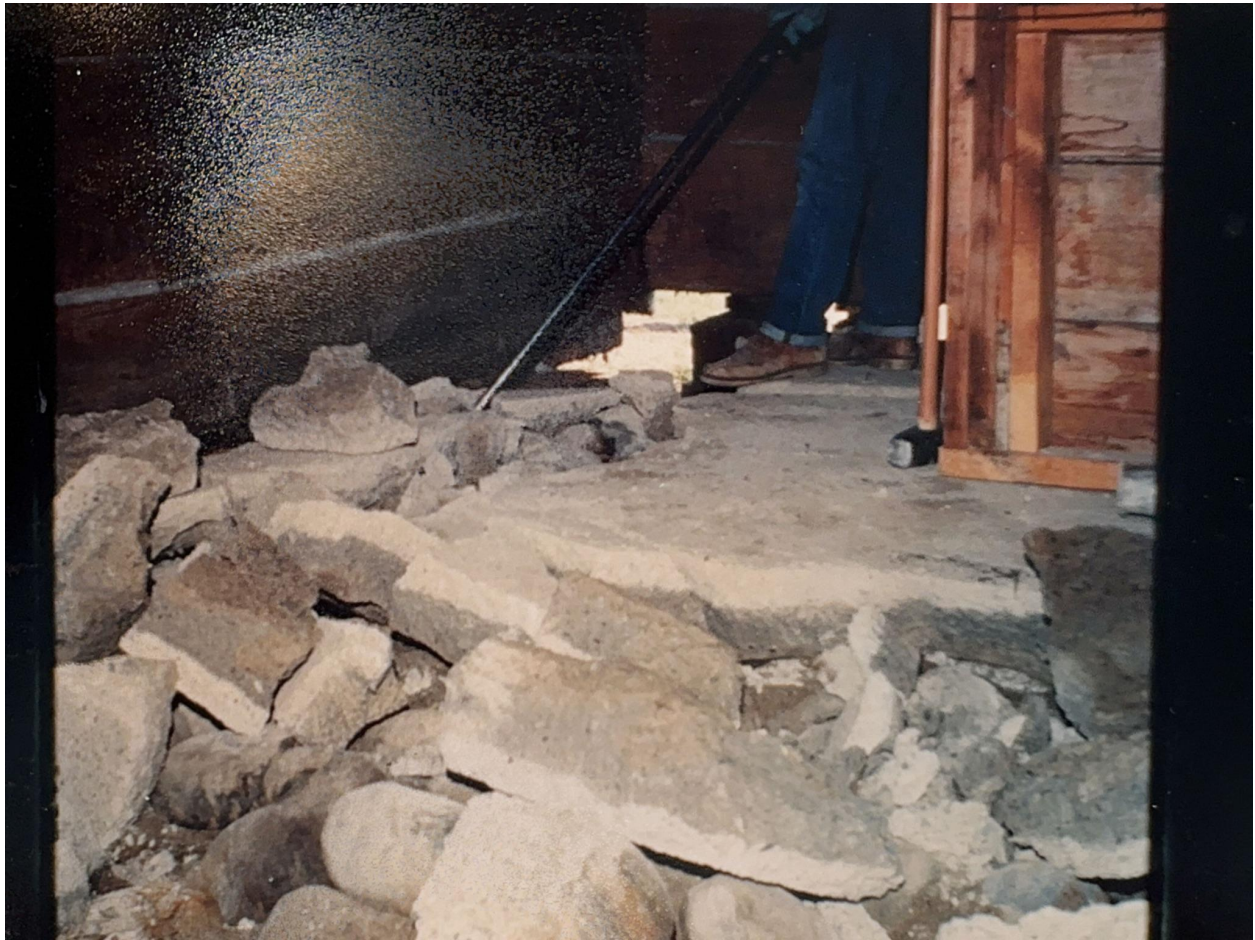
P-36

Removal of the flooring revealed a concrete slab that had to be removed if the restoration was to be completed. So, we rattled our fillings a little more breaking up the cement.

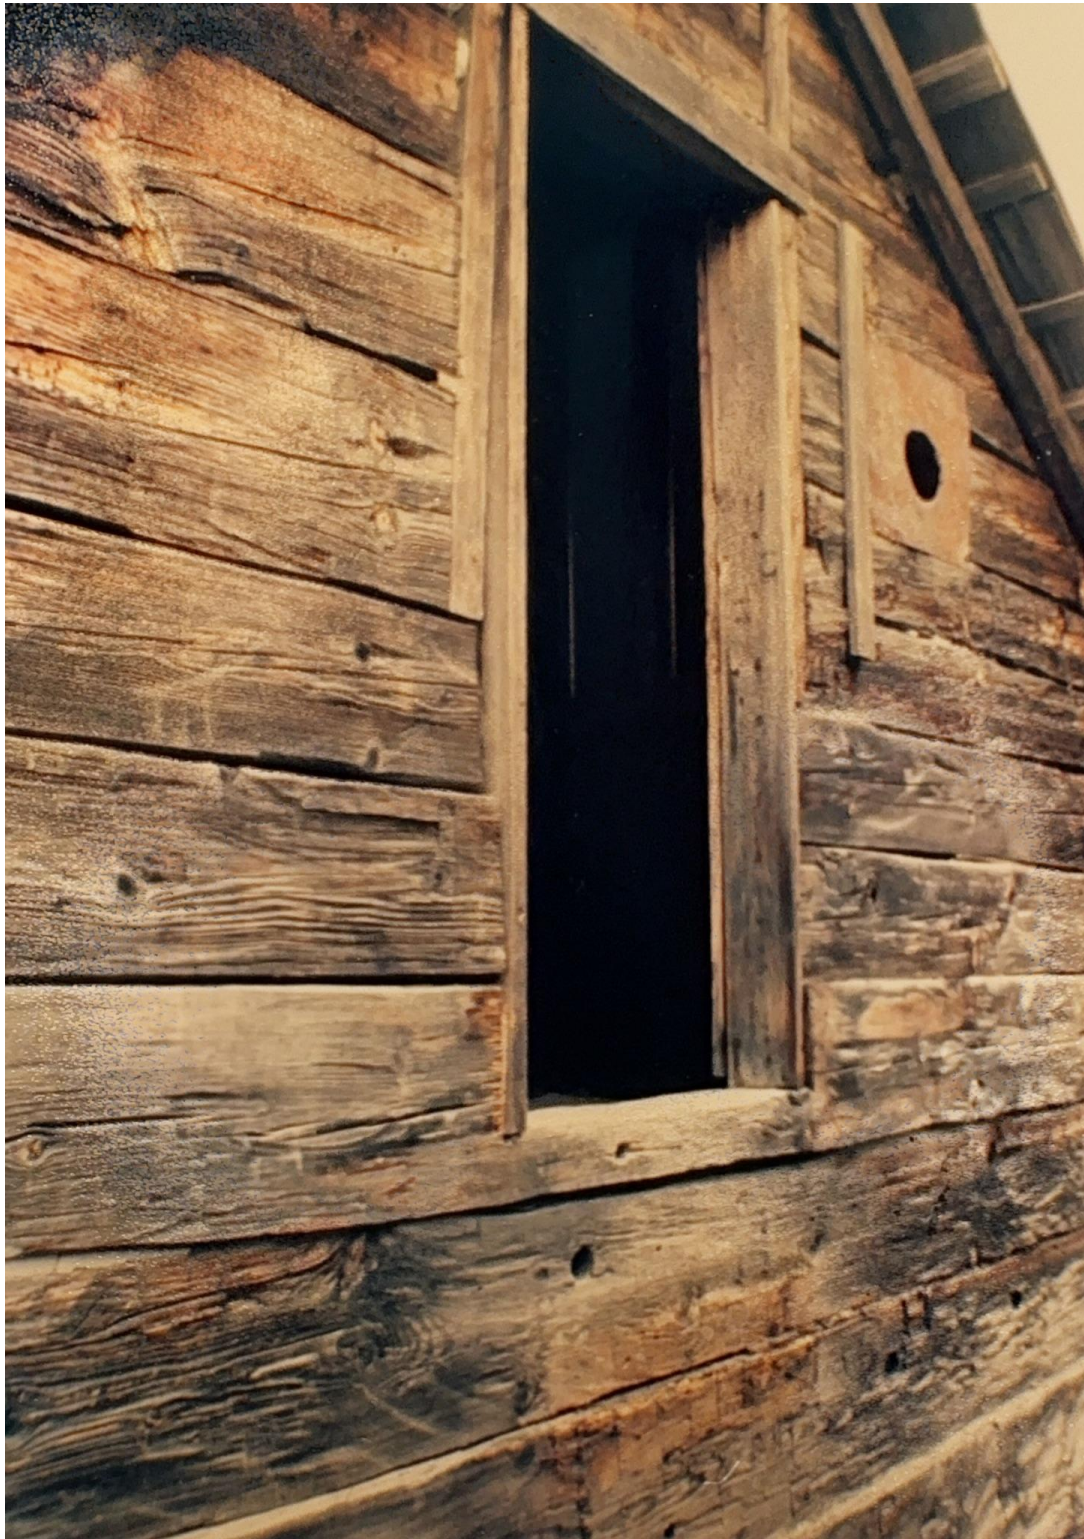
P-50

At some time after the original construction the south wall second floor window was enlarged and a doorway was constructed.
