# 1983 Chapel Restoration

This report documents the conservation work carried out at the Pandosy Mission Historic site on the Father Pandosy Chapel between September 29 and December 20 of 1983. The project was initiated and funded by the Building Committee of the Okanagan Historical Society, with the support of a grant from the B.C. Heritage Trust.

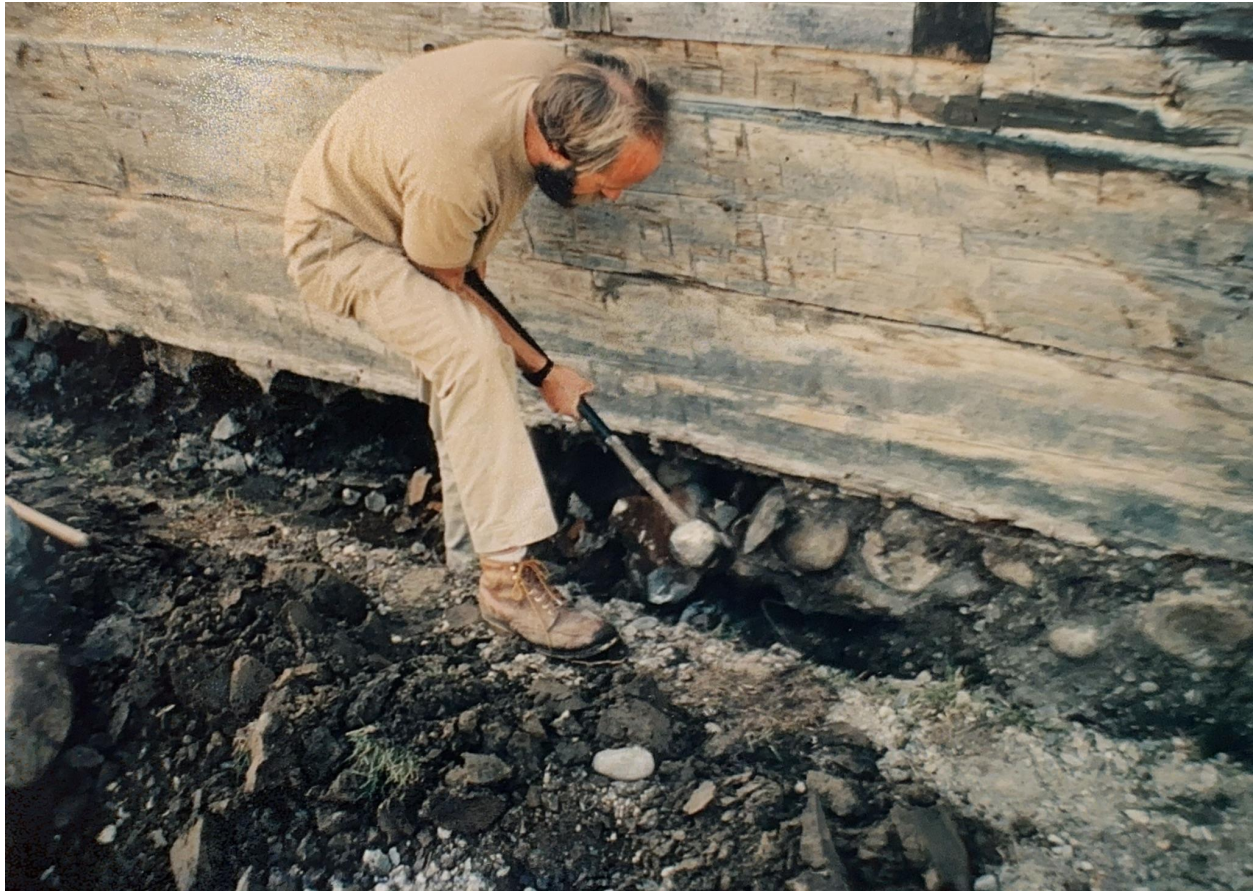
P-12

Using a sledge hammer the surface of the concrete and parts of the rock and mortar foundation were removed.

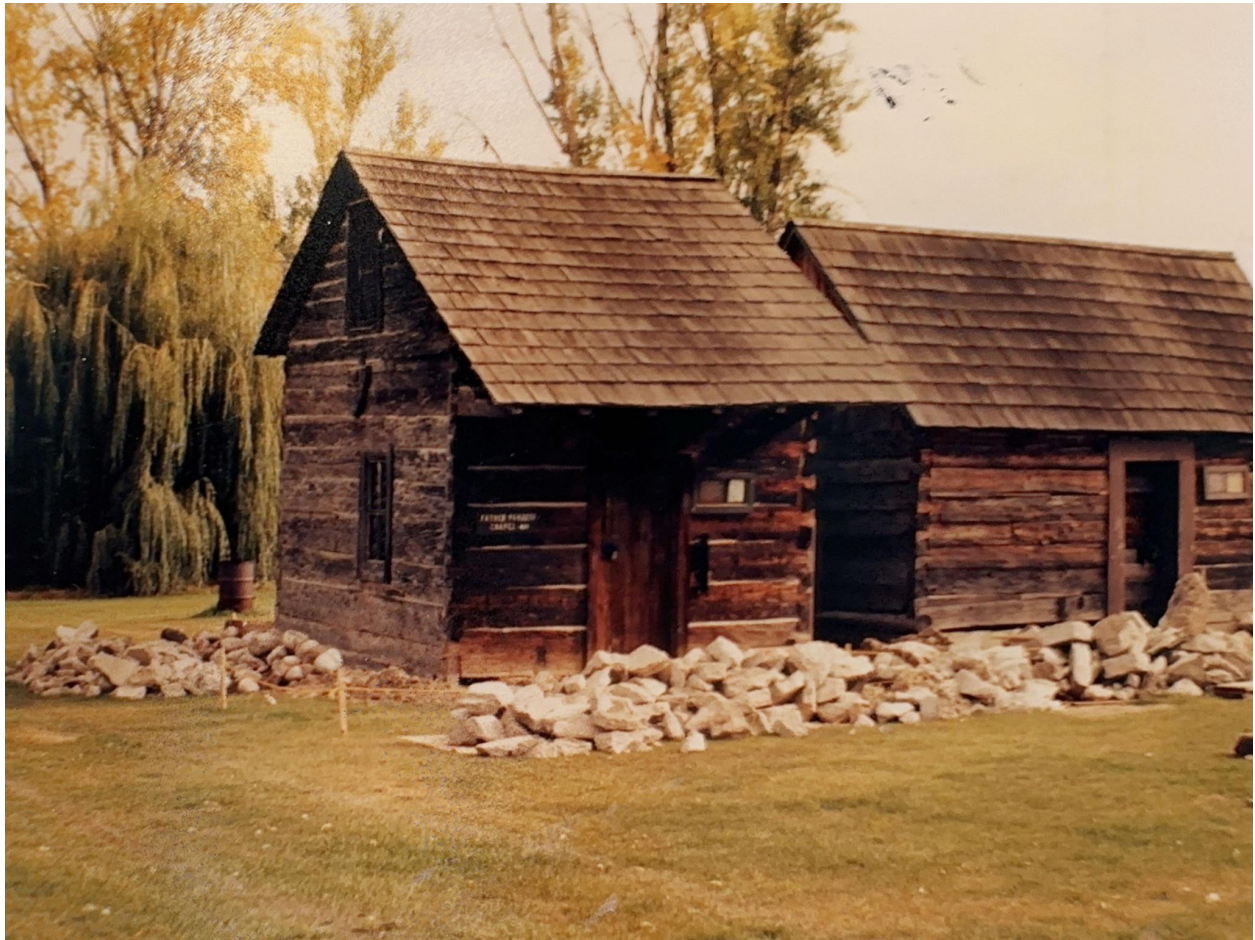
P-22

In this photo the sill log in the east wall is removed for duplication.

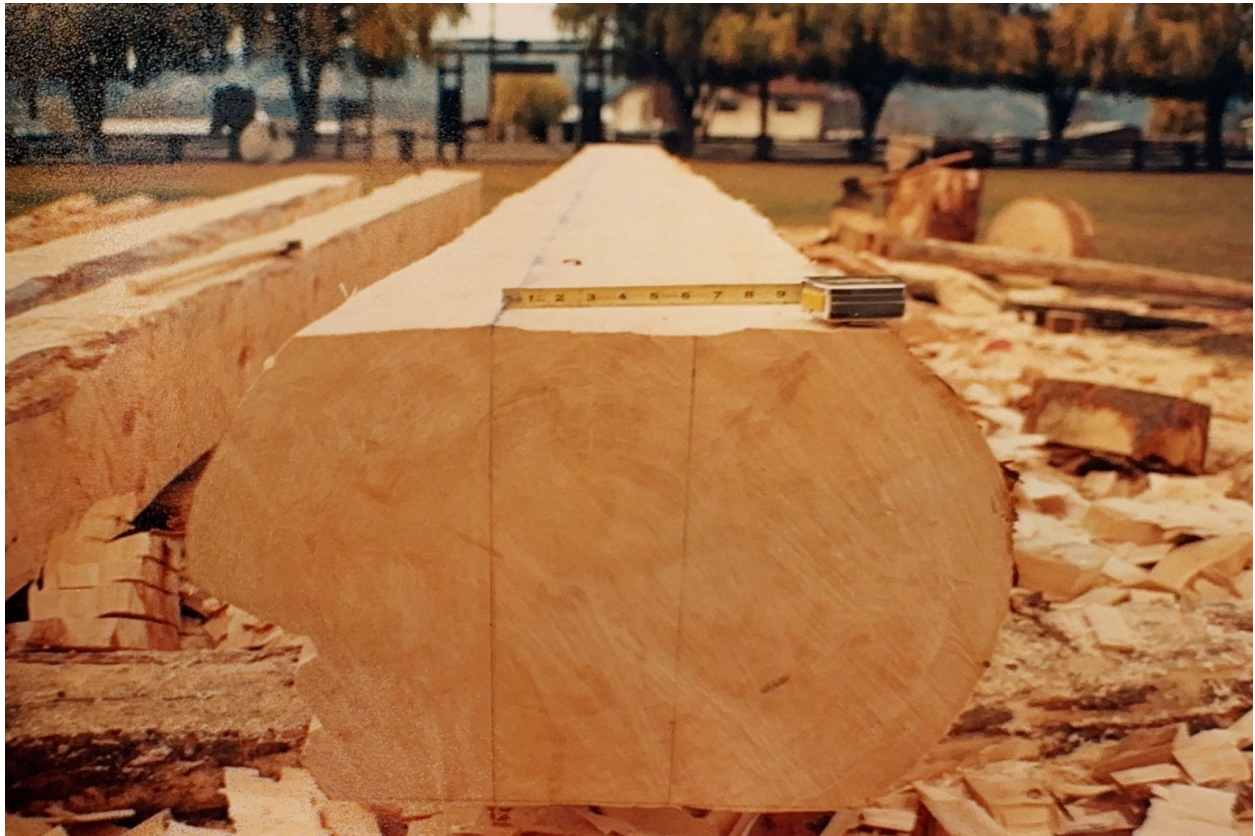
P-25

To aid the hewing process a chainsaw was used to score the logs to within an inch of the desired size.

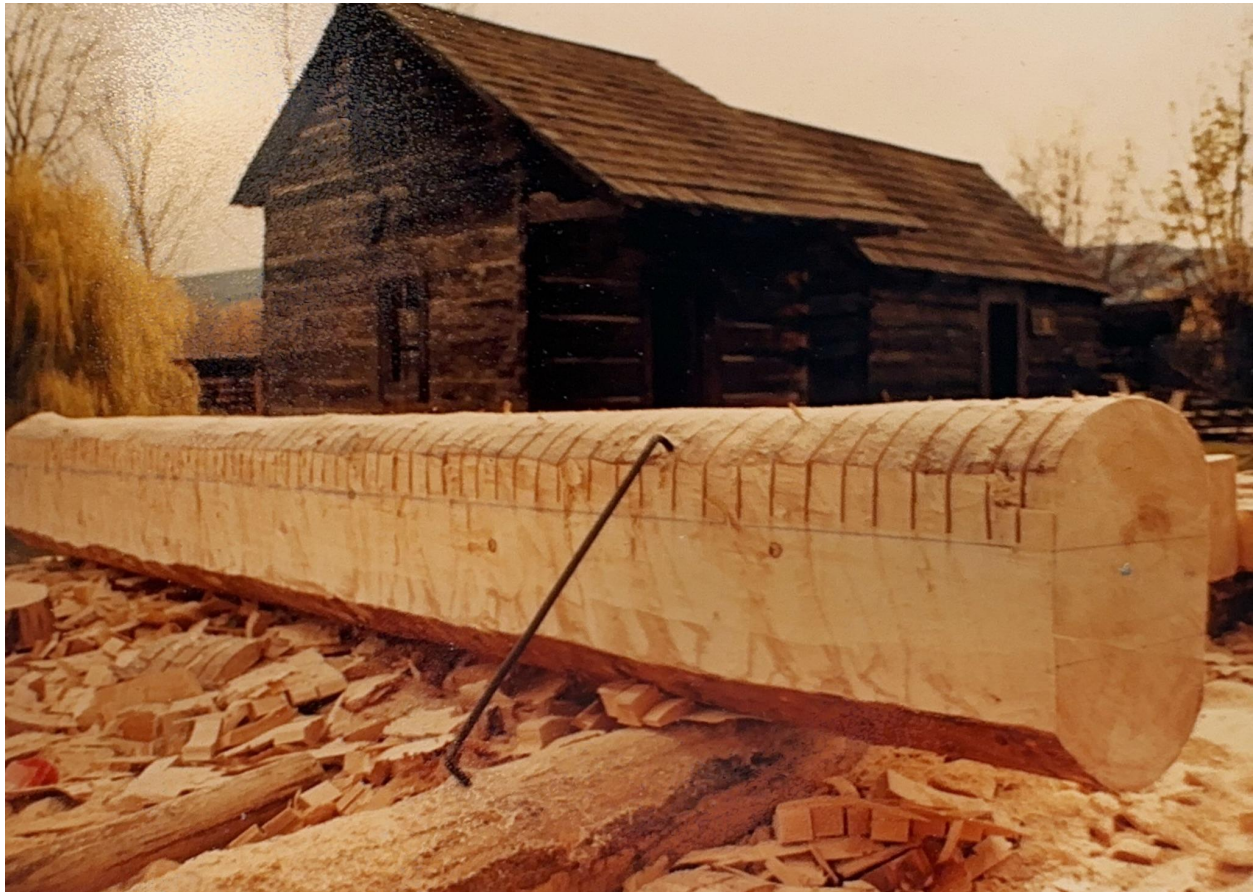
P-27

A broad axe was used to hew the logs to the desired size. The traditional tool created the unmistakable finish of hewing and scoring on the replacement material.

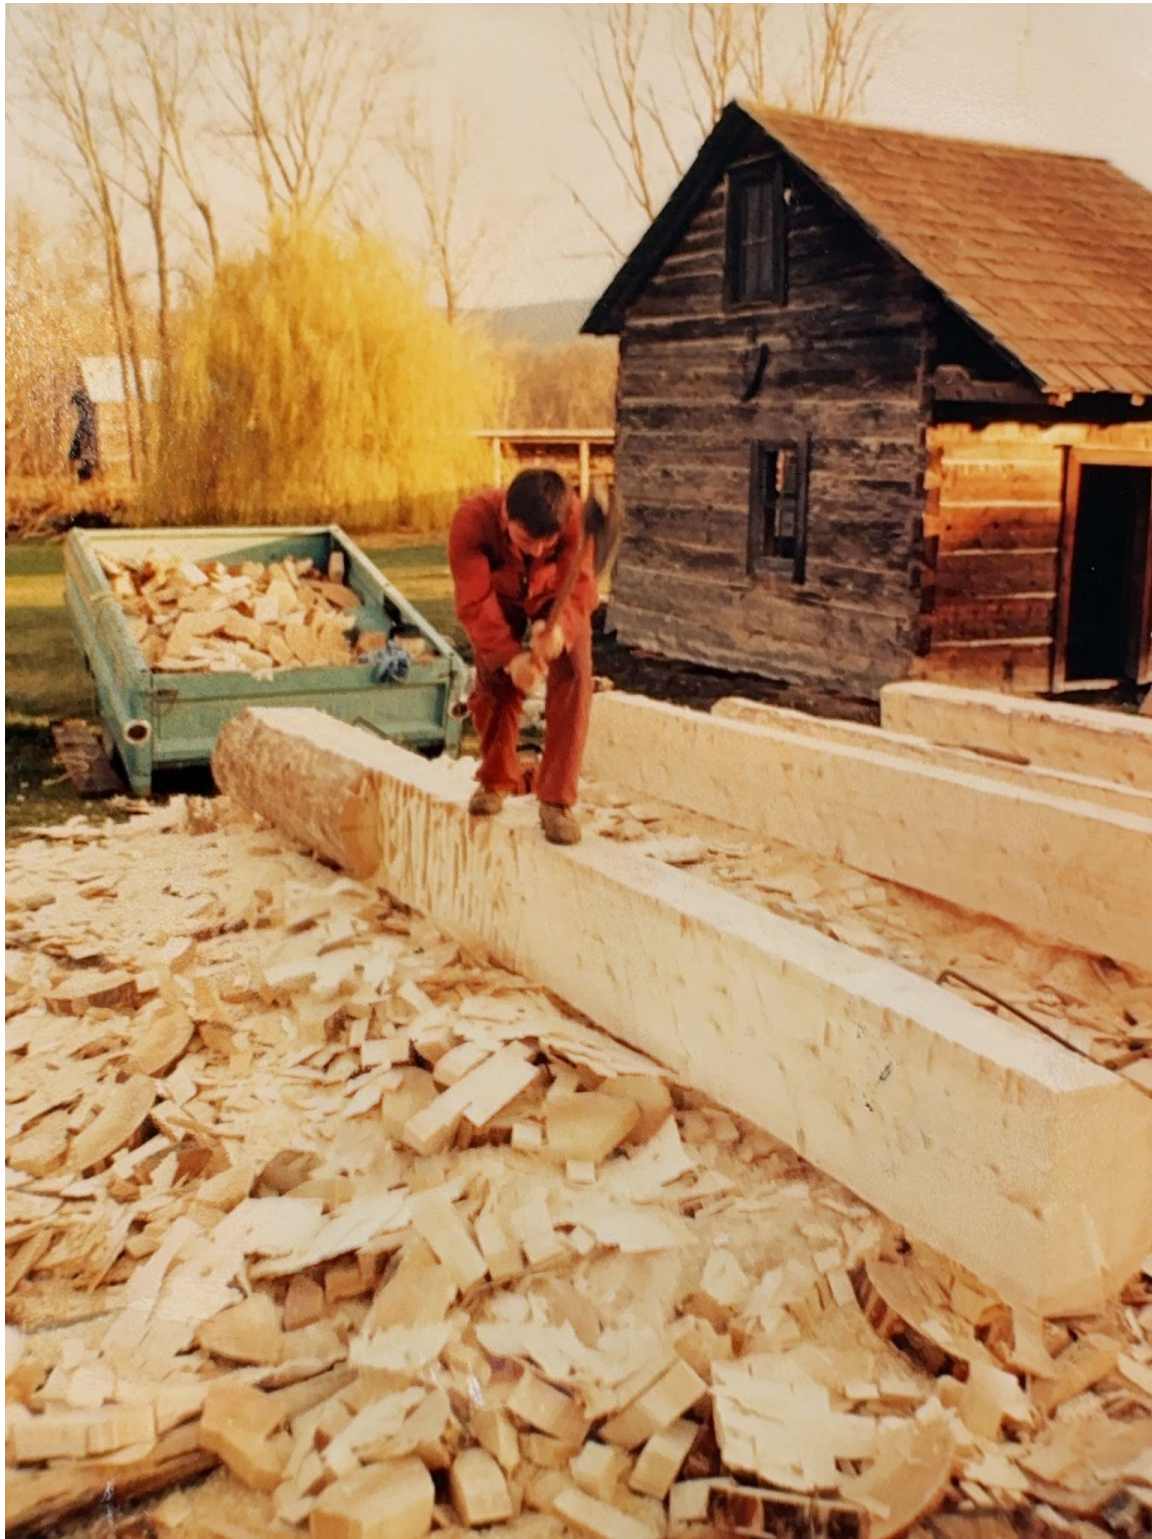
P-30

With the hewing complete, the logs were scribed and fitted to the existing wall.

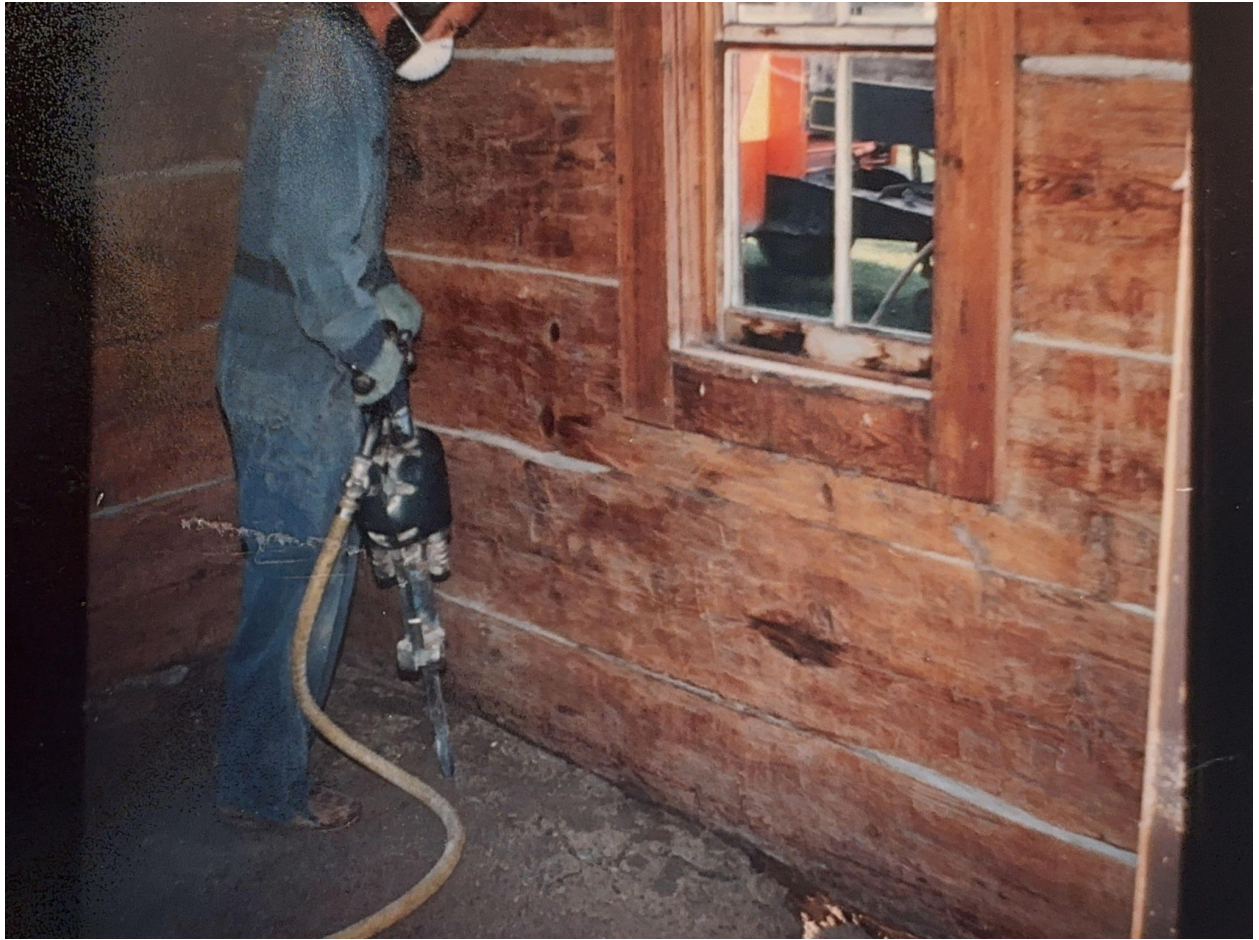
P-36

Removal of the flooring revealed a concrete slab that had to be removed if the restoration was to be completed. So, we rattled our fillings a little more breaking up the cement.

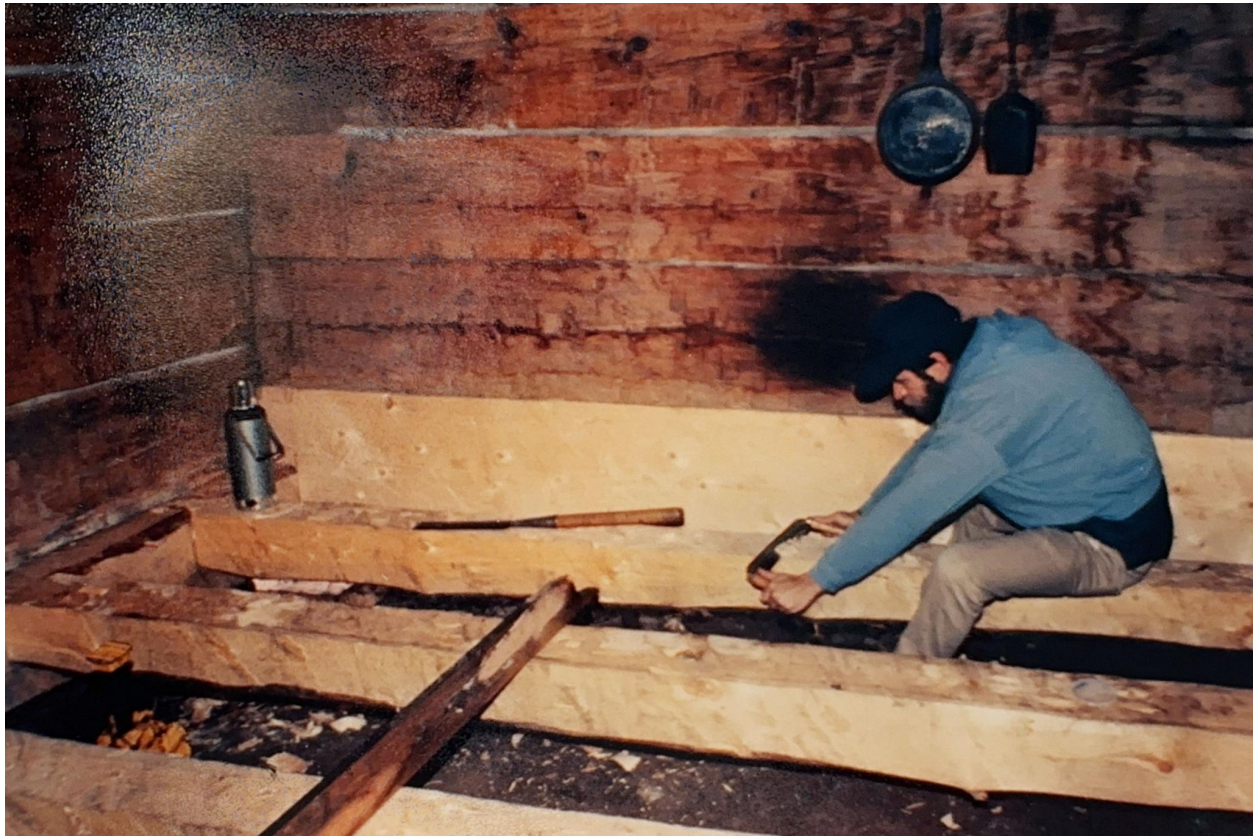
P-44

The planed, kiln-dried lumber was pre-stained to soften the impact of the new wood. The floor was fastened with square cut nails.

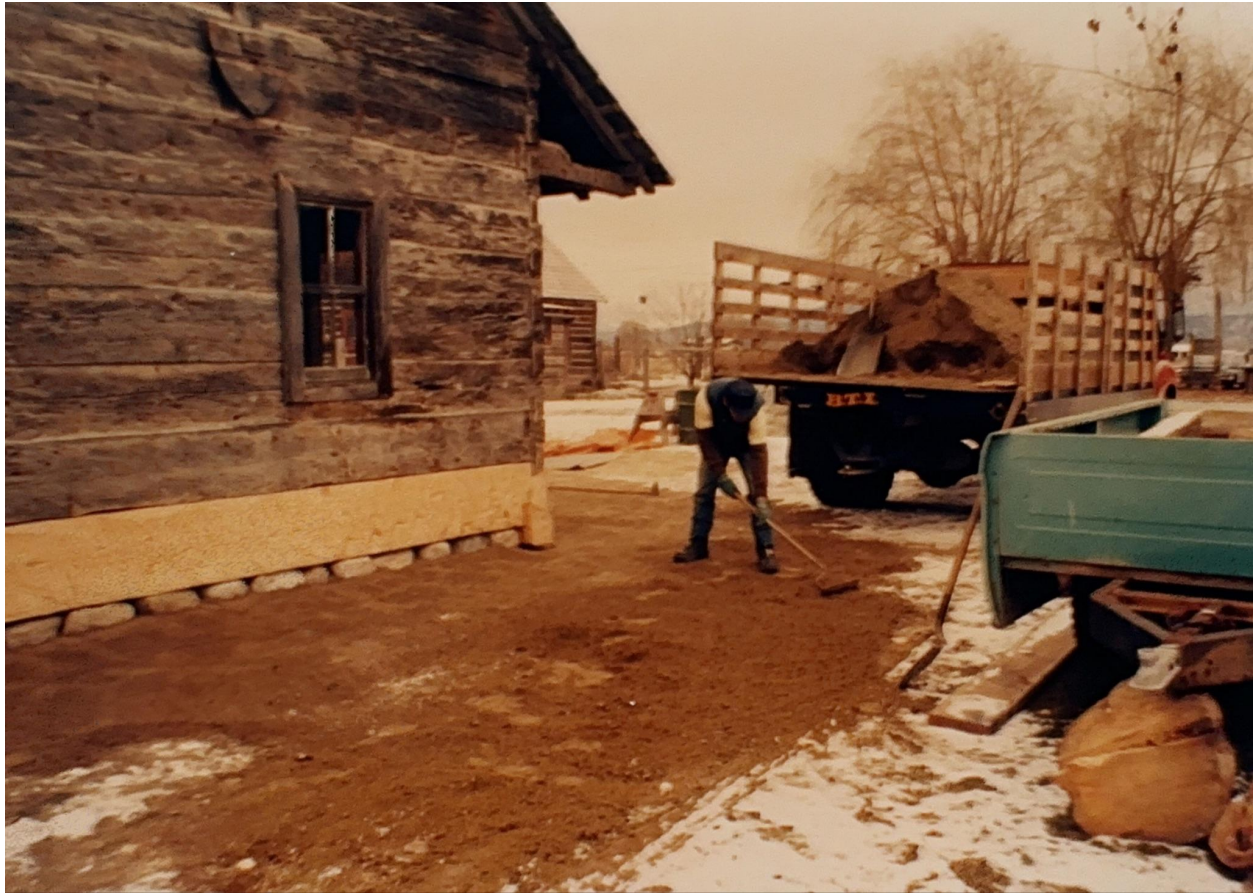
P-47

With the log work completed the building was set on foundation stones, appropriate to the original style of construction.

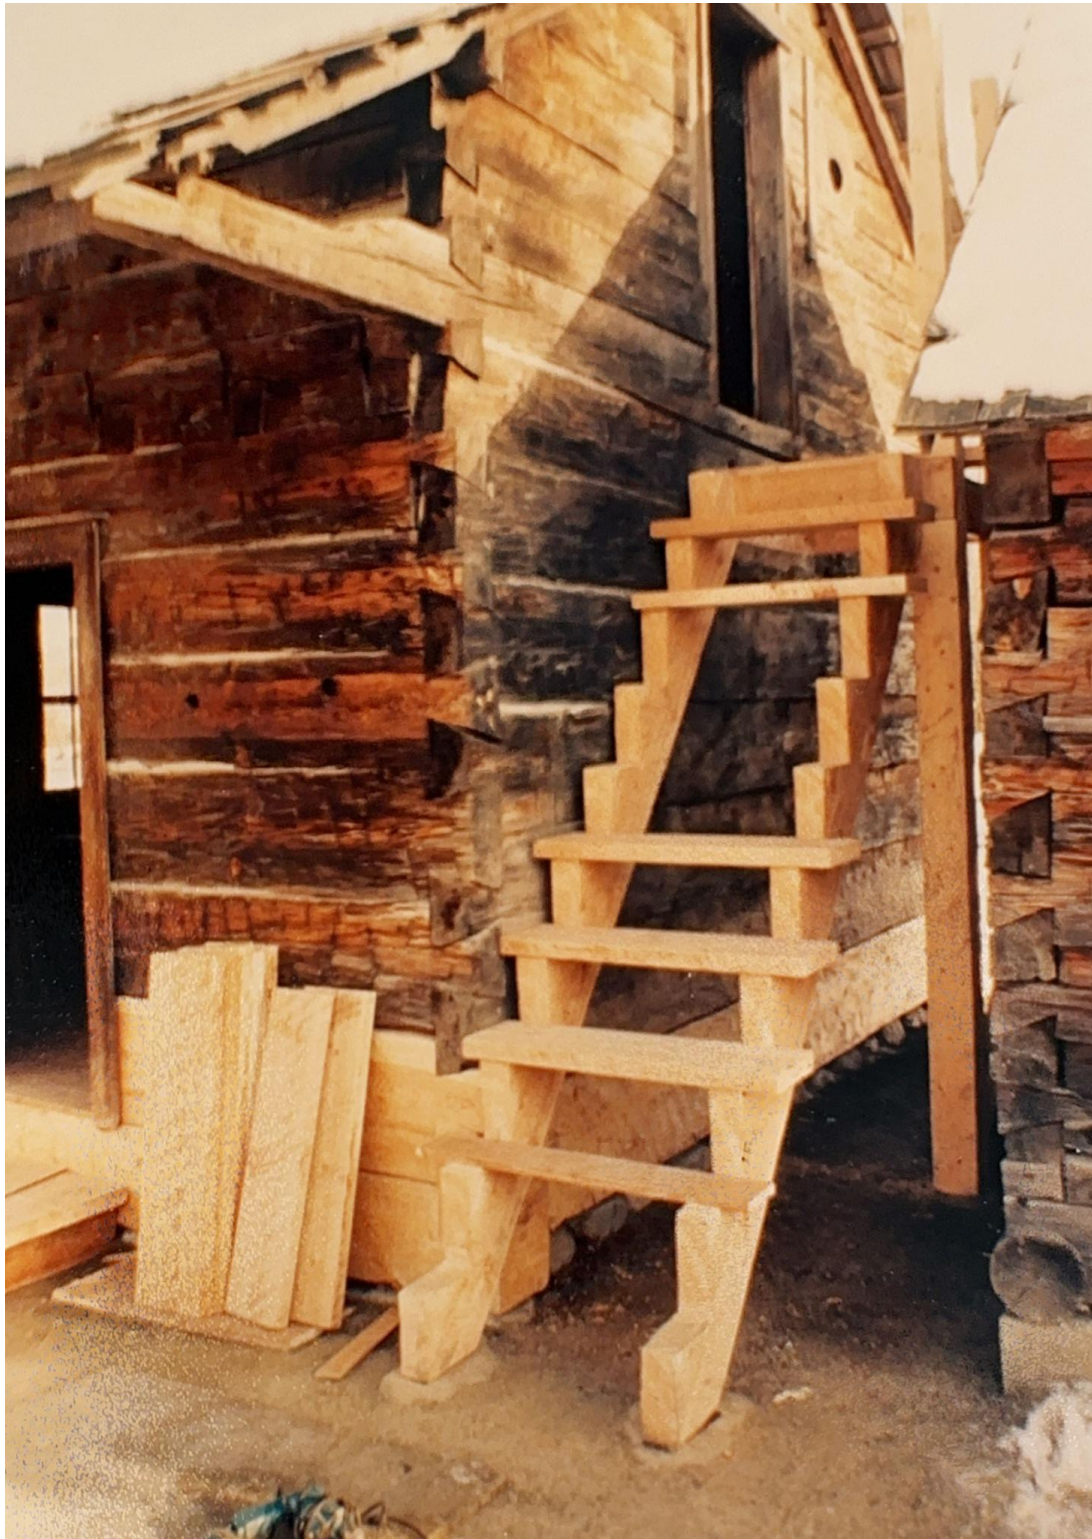
P-31A

The new staircase was constructed with large dimension lumber appropriate to the period. The risers and support posts were hewn and the treads were hand planed. Square nails were used to fix the treads to the risers, which are set on stones.

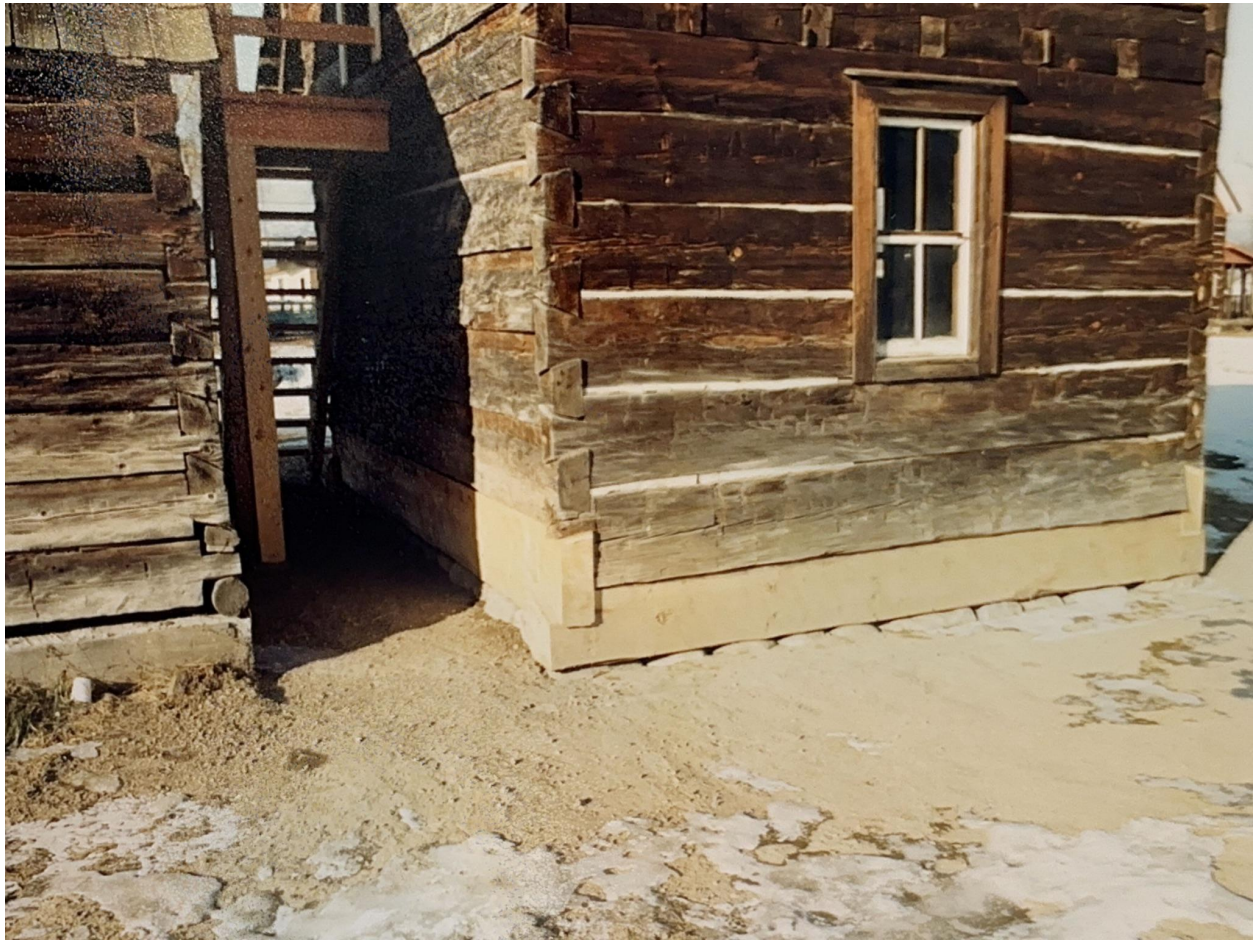
P-8

The completed restoration project with the ground landscaped and the building set on a stone foundation.
